June 28, 2019
File No. 262018.063

Subject: Department of Natural Resources Washington Geological Survey,
School Seismic Safety Assessment Project, Contract No. AE 410 -
Seismic Evaluation for **Spokane School District**

School Buildings Evaluated in the Spokane School District

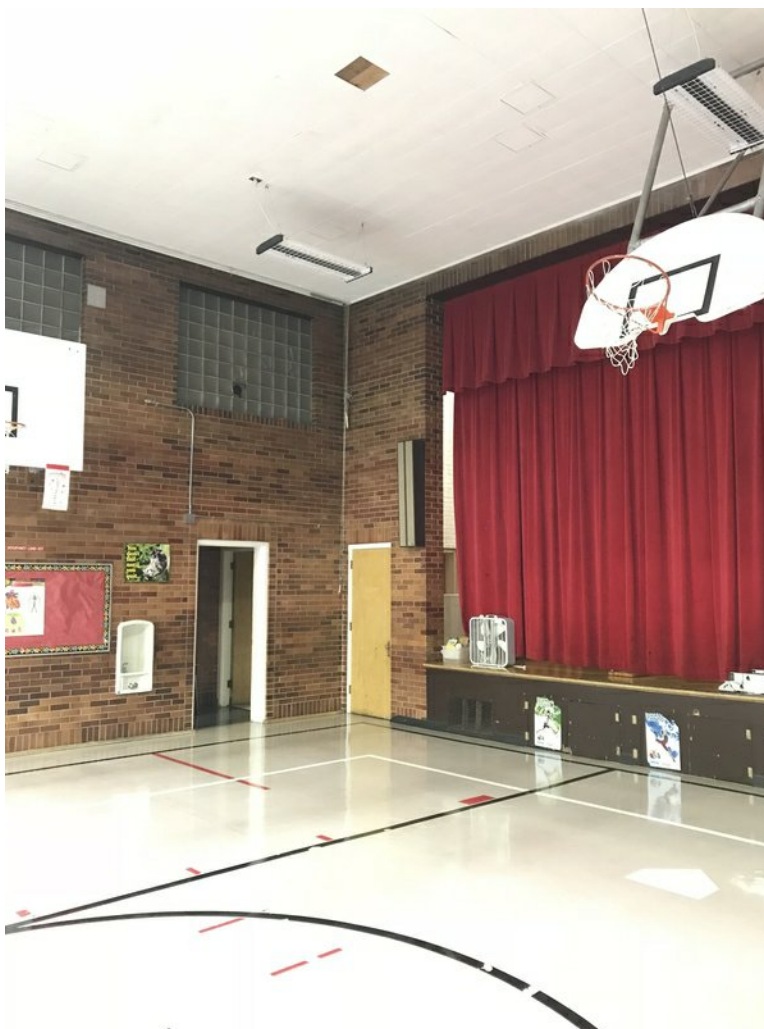
Figure 1-1. Interior space at gymnasium with stage area to the right in the photo.

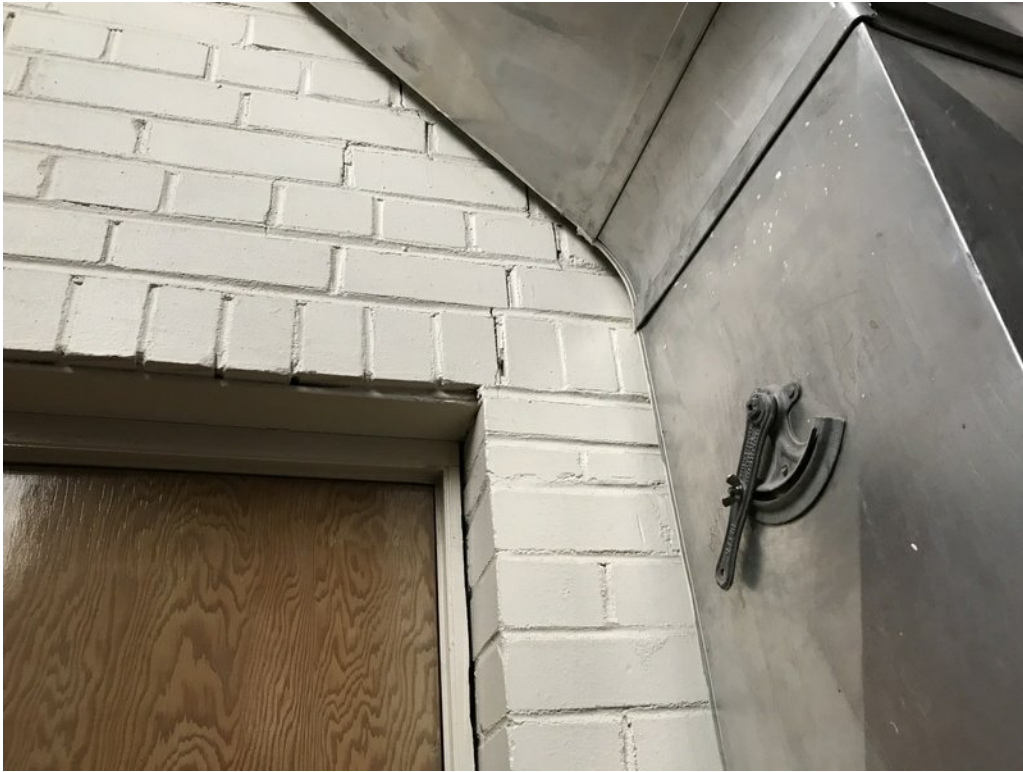
Figure 1-2. Upper corner of doorway between stage and music room. Steel lintel can be seen supporting brick at head of opening.

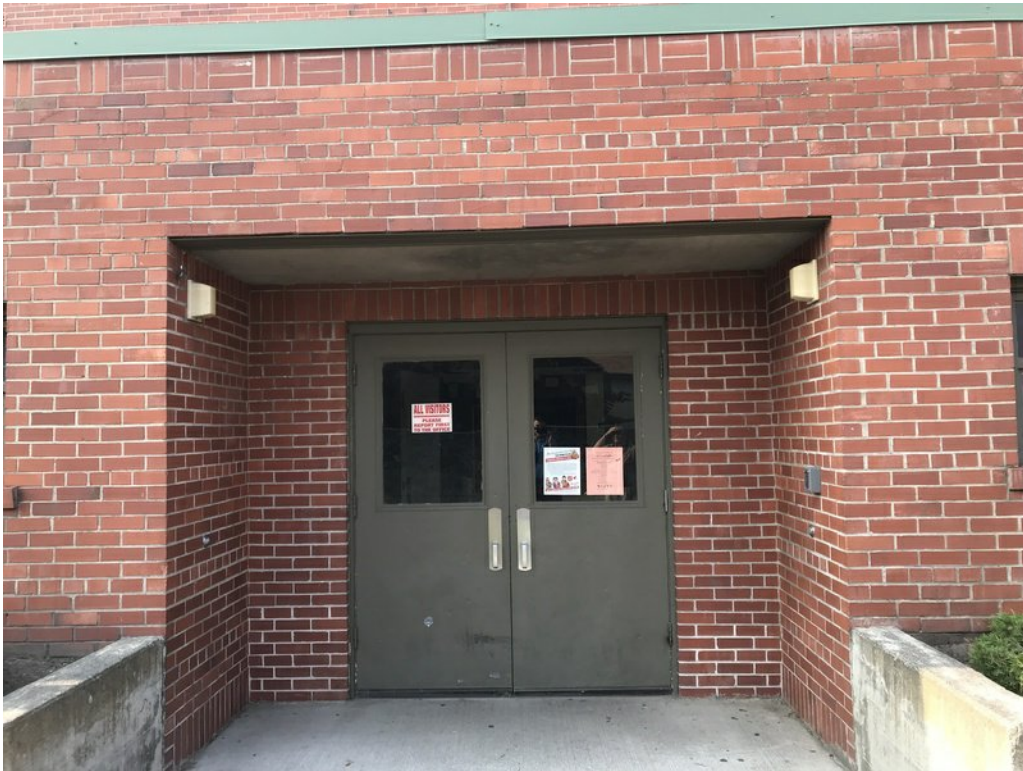
Figure 1-3. North entryway.

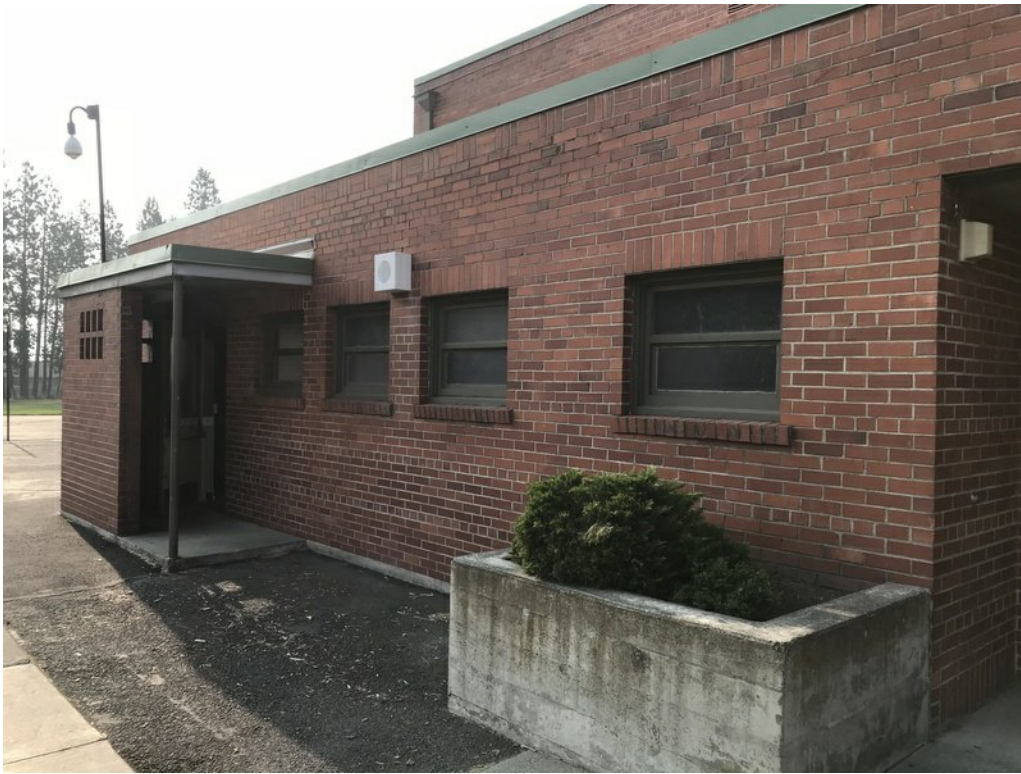
Figure 1-4. Northeast exit from teachers' lounge.

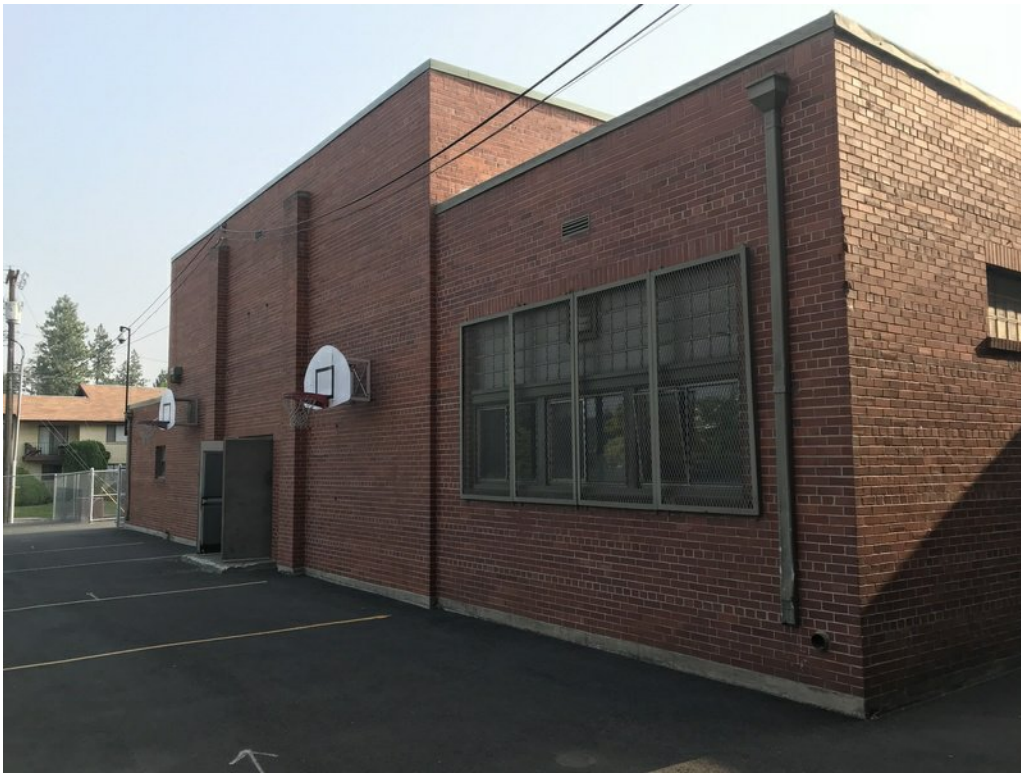
Figure 1-6. View from southwest corner. The various roof elevations can be seen here as well as the exterior pilasters at the west wall of the gymnasium.

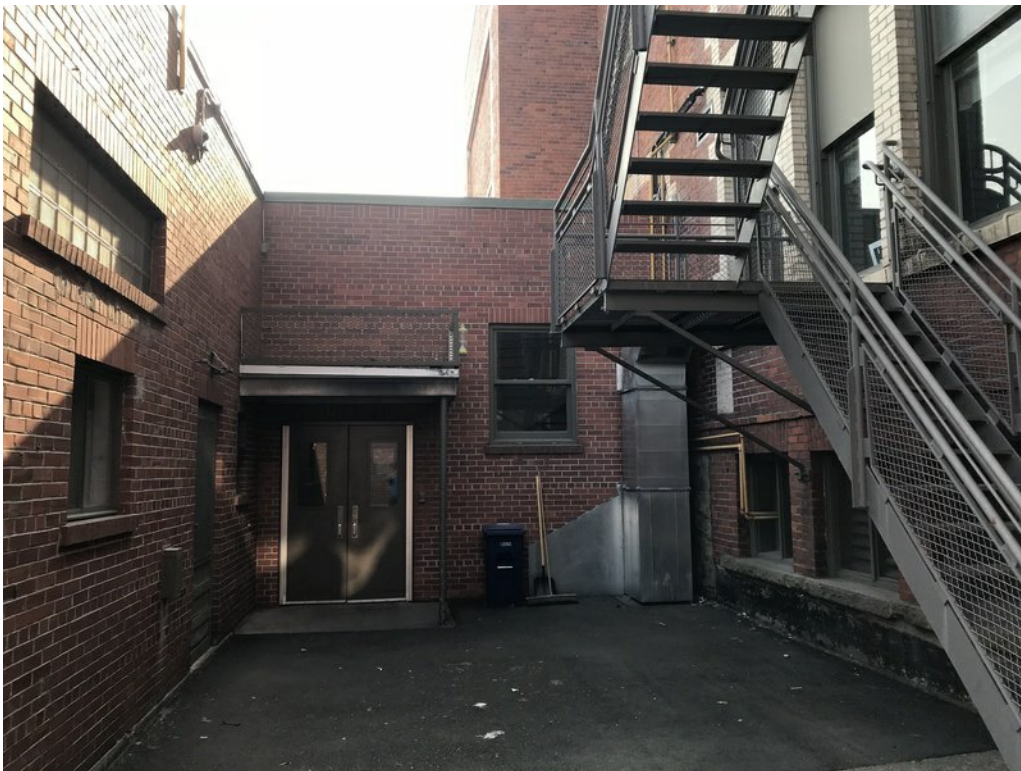
Deficiency	Description
Adjacent Buildings	There was no joint observed between this building and the main building.

Figure 1-7. View looking west at the south portion of the building where it abuts the main school building (to the right).

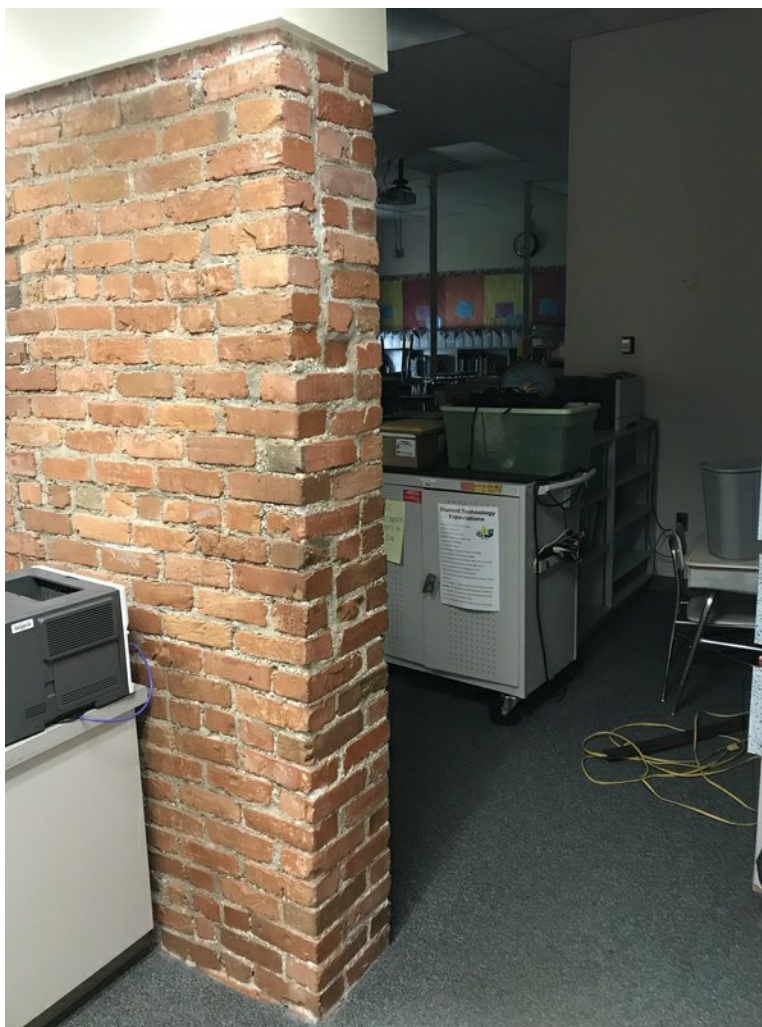
Figure 1-1. Interior exposed URM wall.

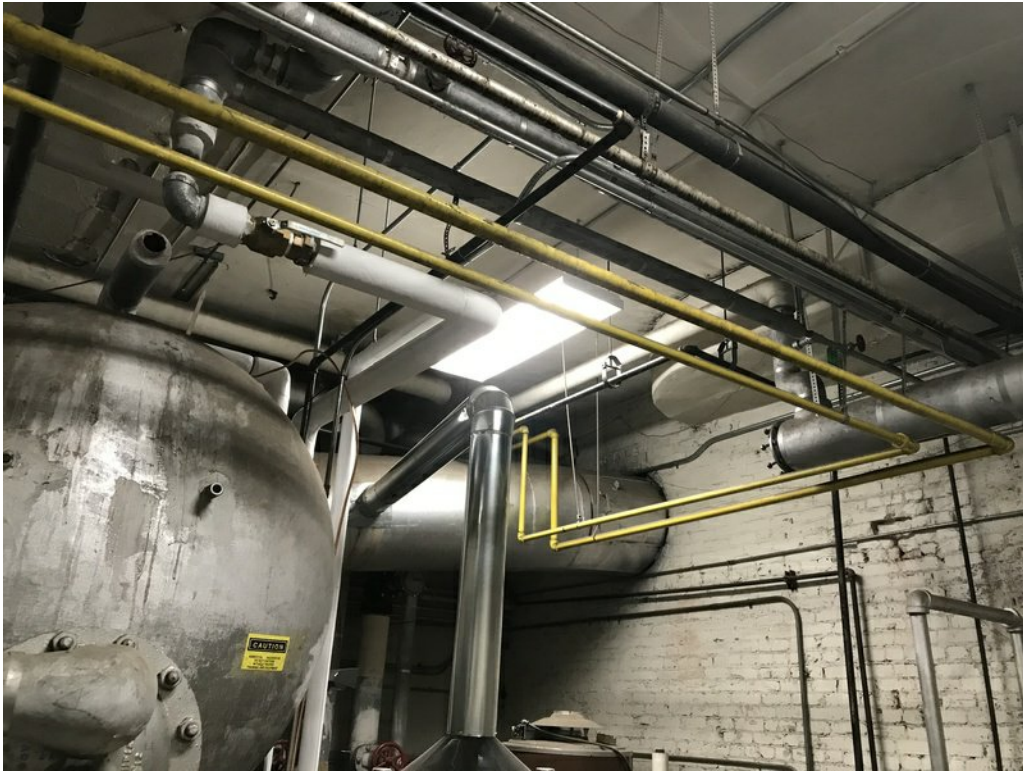
Figure 1-2. Mech Room - gas piping is painted yellow

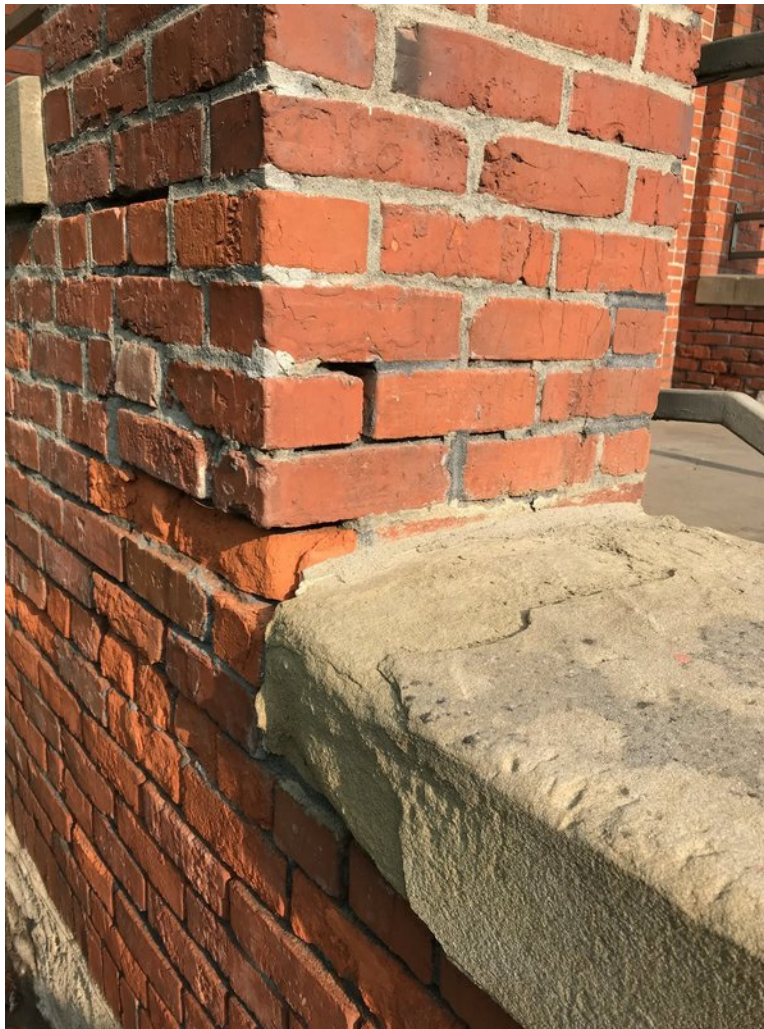
Figure 1-4. Deteriorated mortar in masonry column at east entry

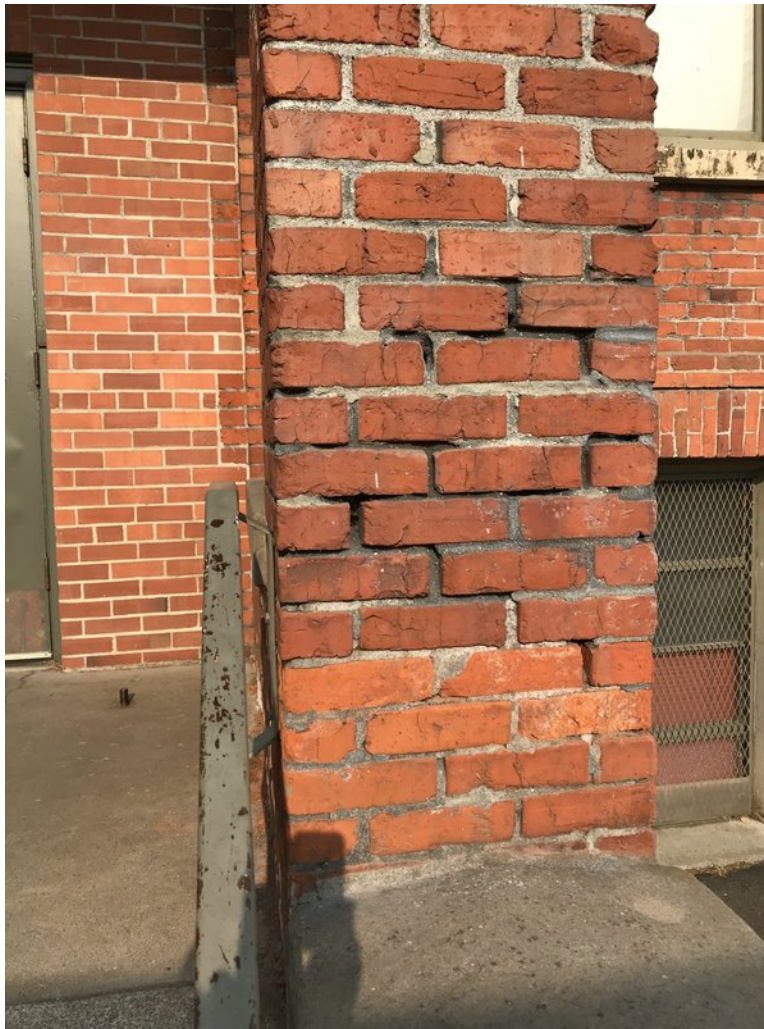
Figure 1-5. Deteriorated mortar in masonry column at east entry

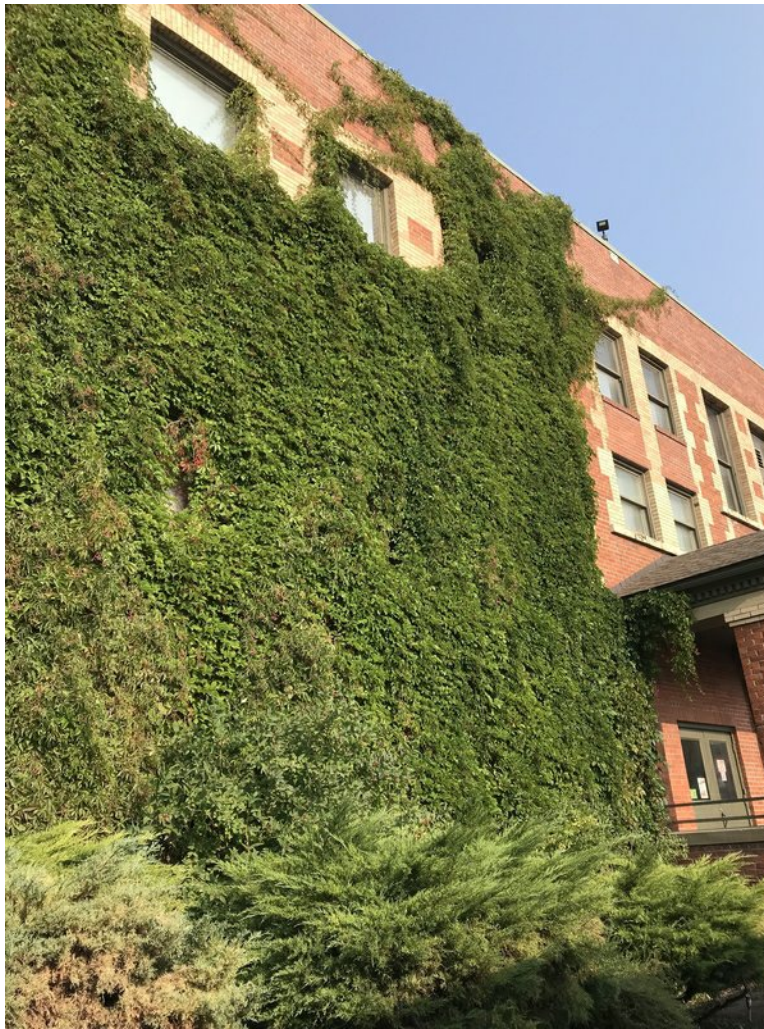
Figure 1-6. Ivy growth on east wall of building

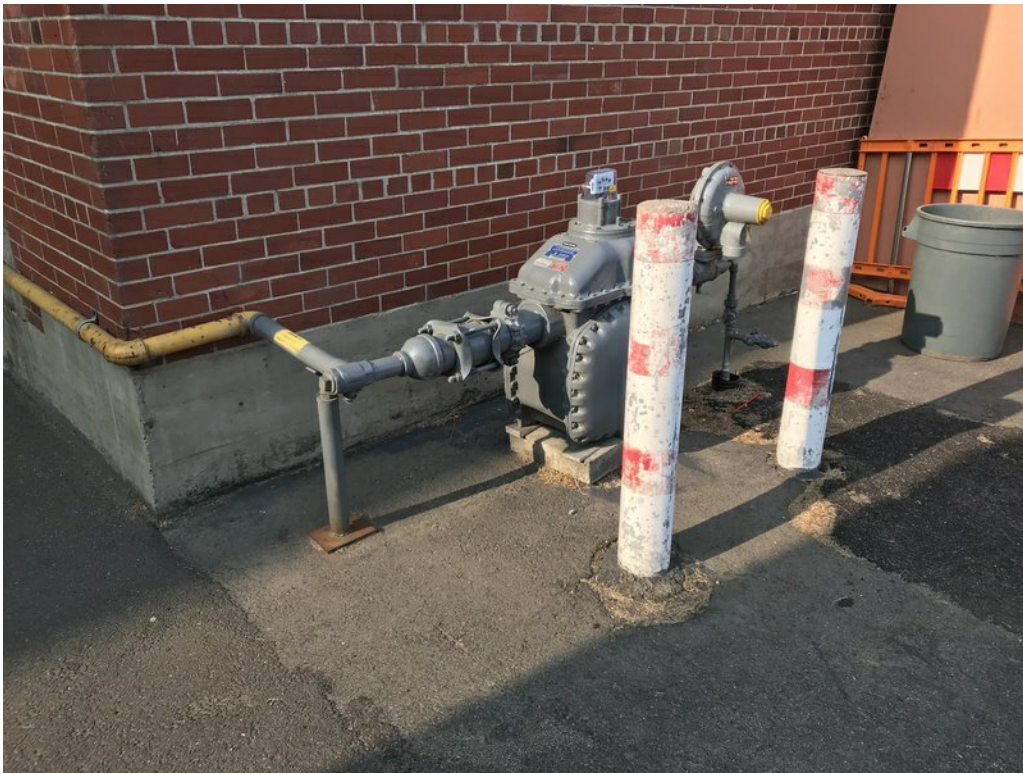
Figure 1-7. Gas meter at northwest corner of building

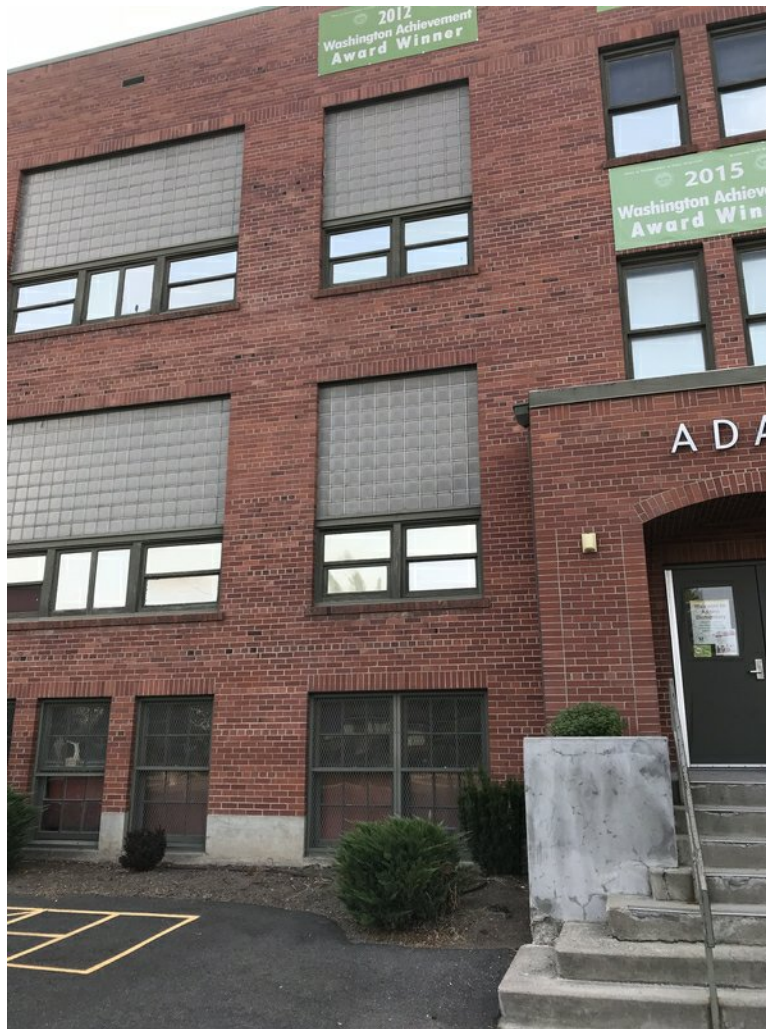
Figure 1-9. West elevation/entry showing infill glass block above windows

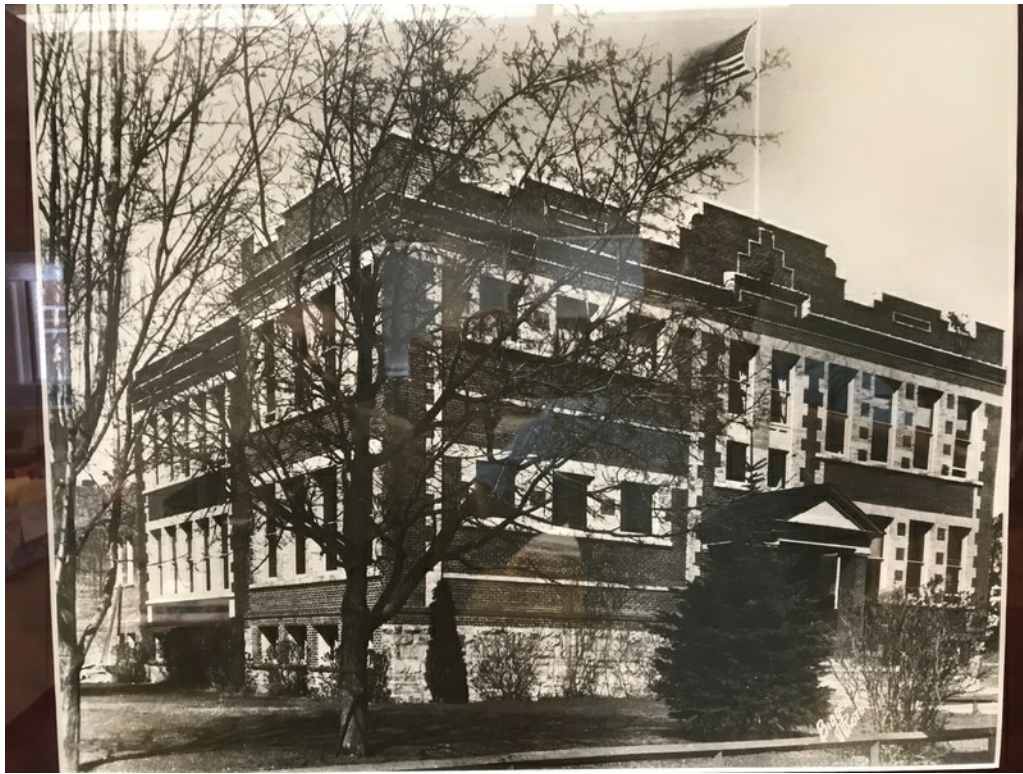
Figure 1-10. Original photo from SE corner of building showing original taller parapet configuration.

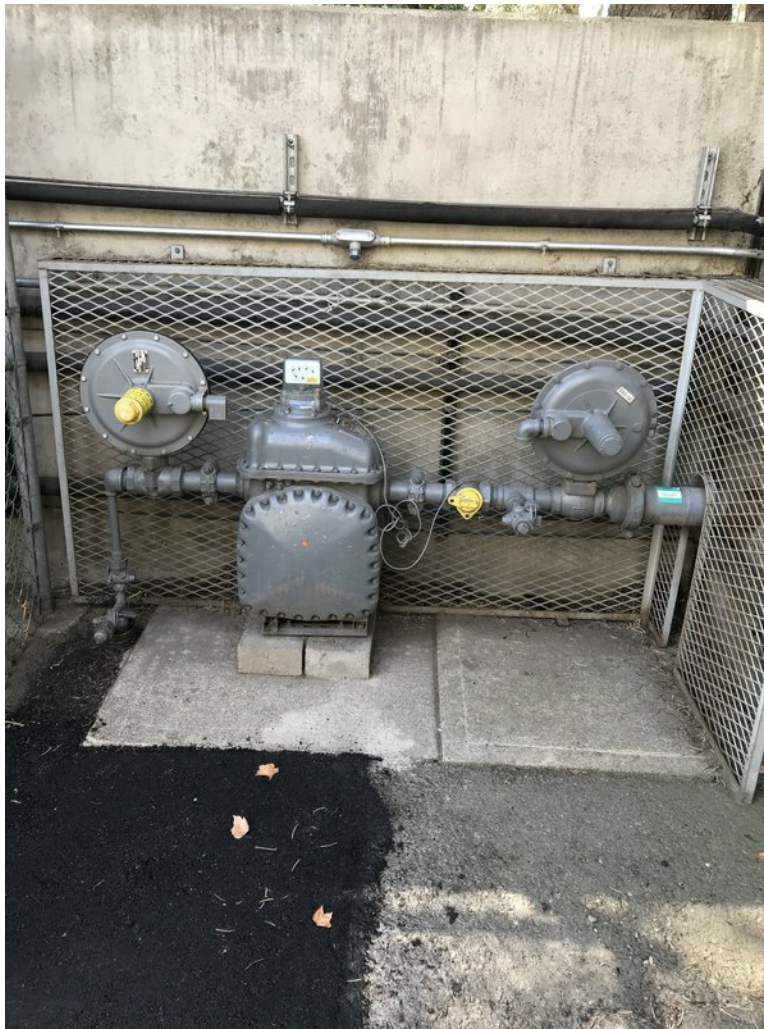
Figure 1-4. Gas meter at exterior of building. No flexible joints were observed.

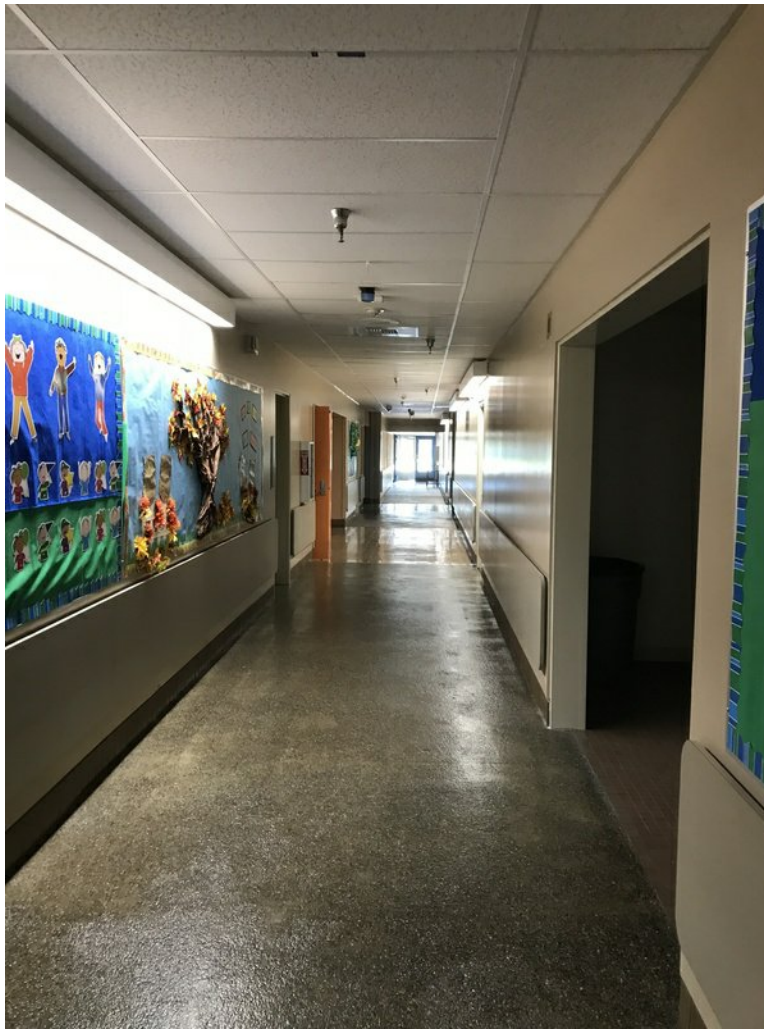
Figure 1-5. First floor corridor looking east. Classrooms are to the left; bathrooms and locker rooms to the right.

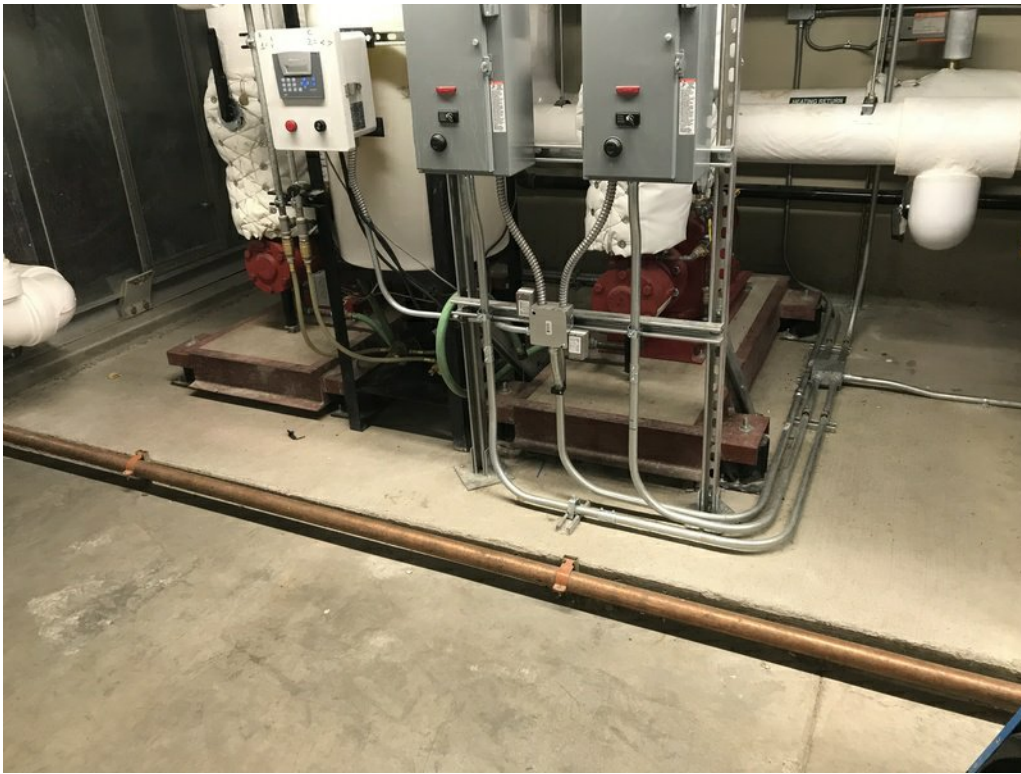
Figure 1-6. Mechanical units on isolating pads.

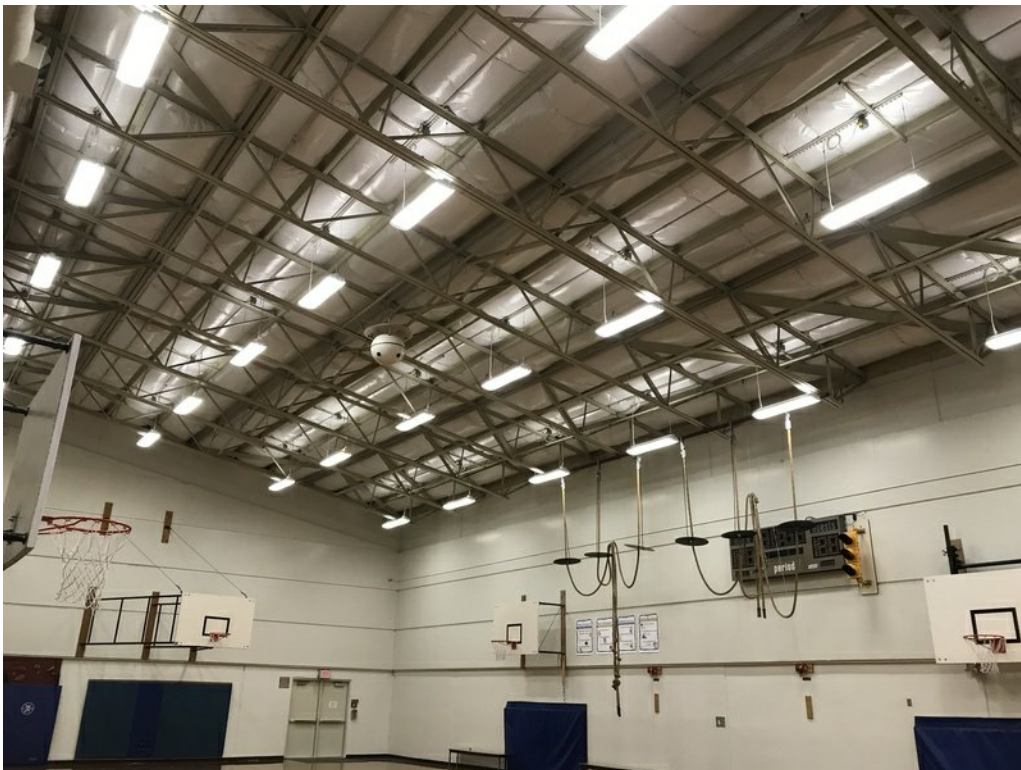
Figure 1-7. Gymnasium with open web steel joist roof structure visible.

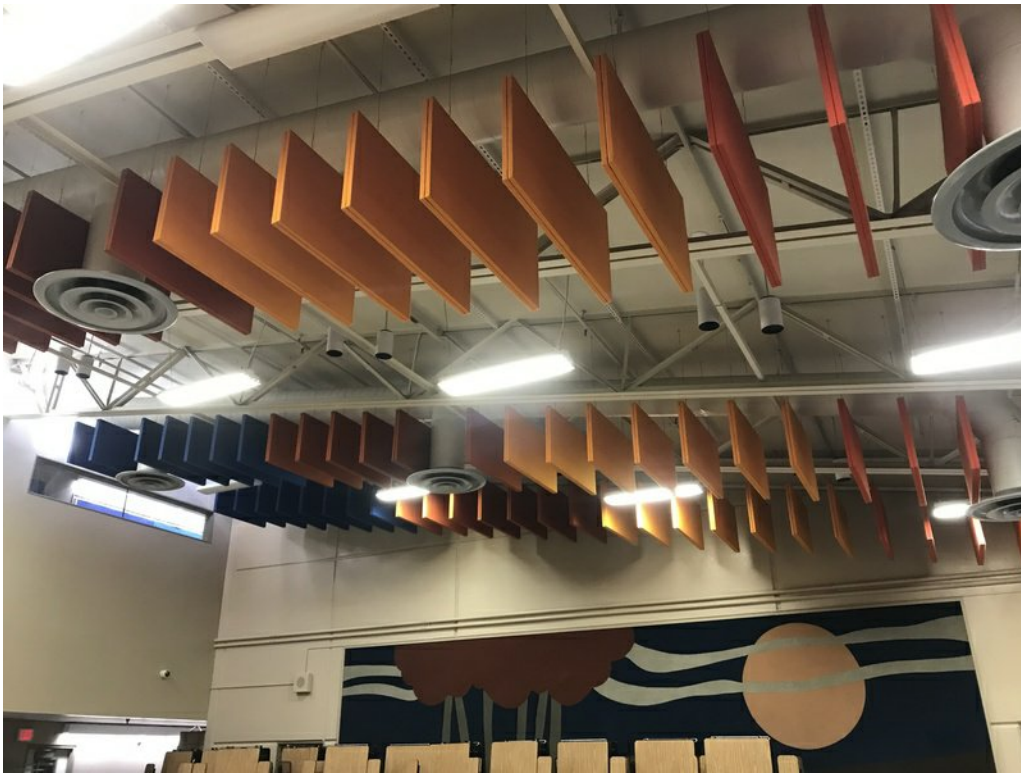
Figure 1-8. Exposed open web steel joists in the multipurpose room.

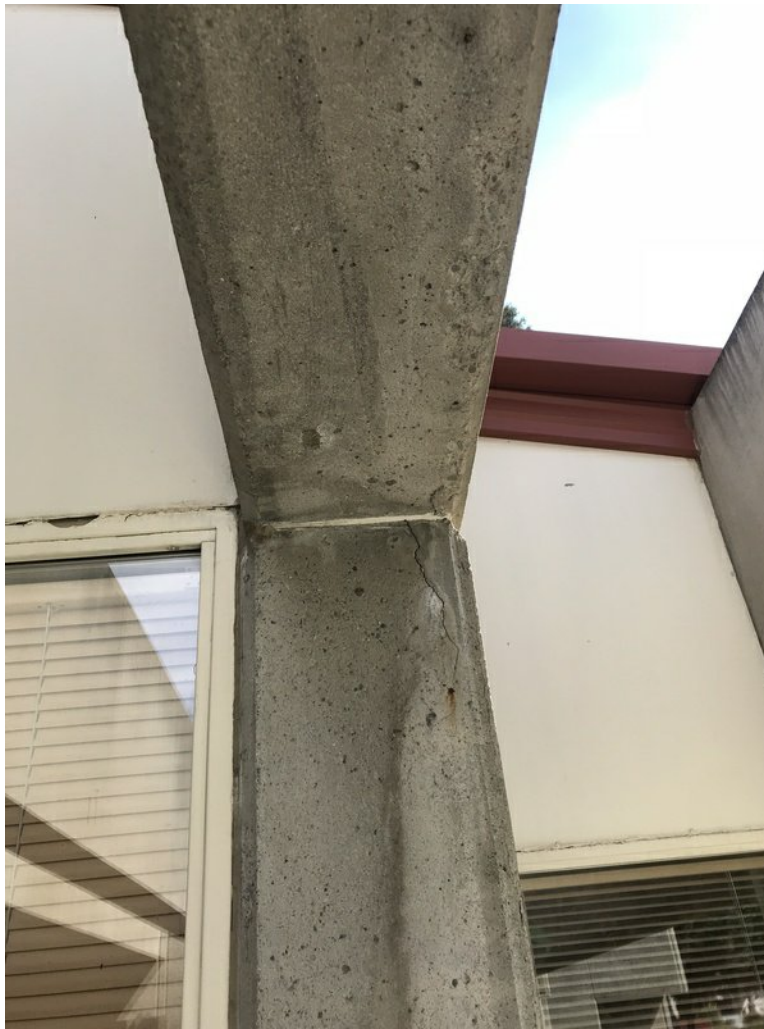
Figure 1-9. Minor cracking at exterior frame.

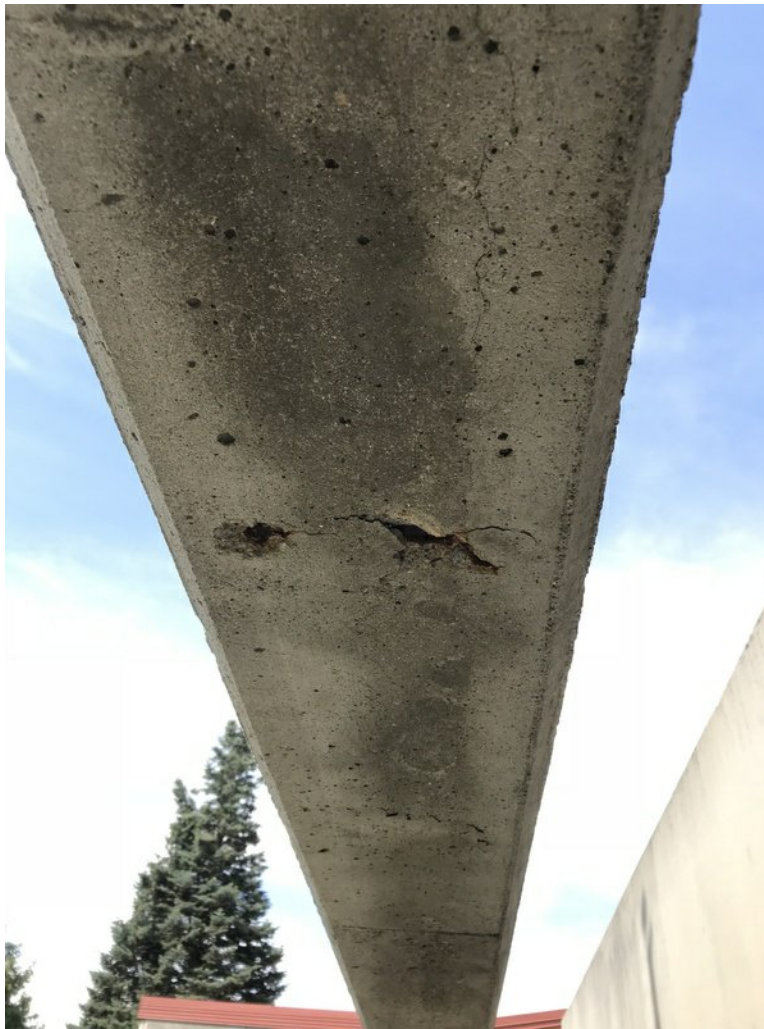
Figure 1-10. Additional cracking seen at exterior frame. It is unclear if the frame members or the wall elements are the lateral system.

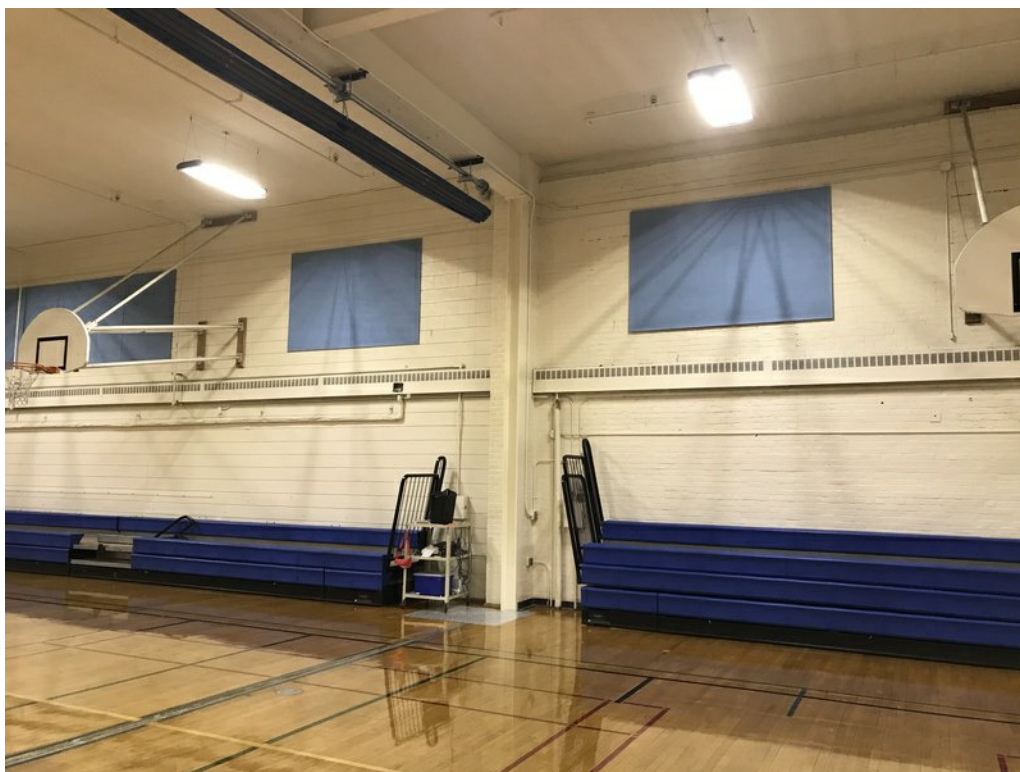
Figure 1-1. Gymnasium

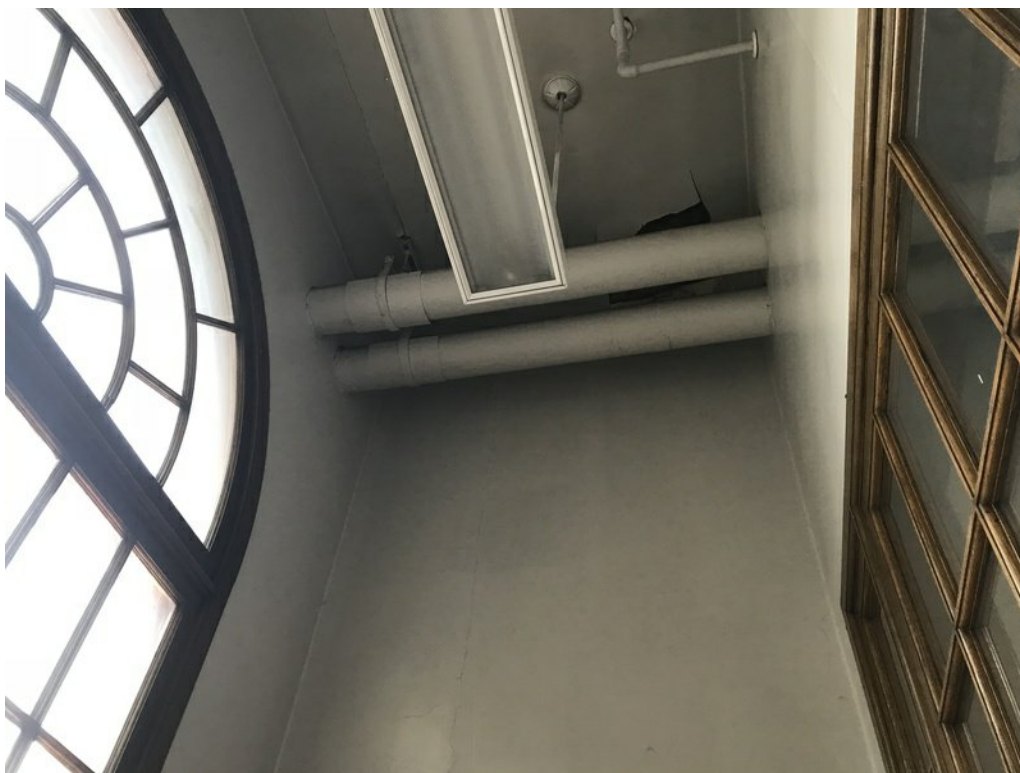
Figure 1-2. Large glazing panel at entry. Deteriorating ceiling finishes can be seen above piping.

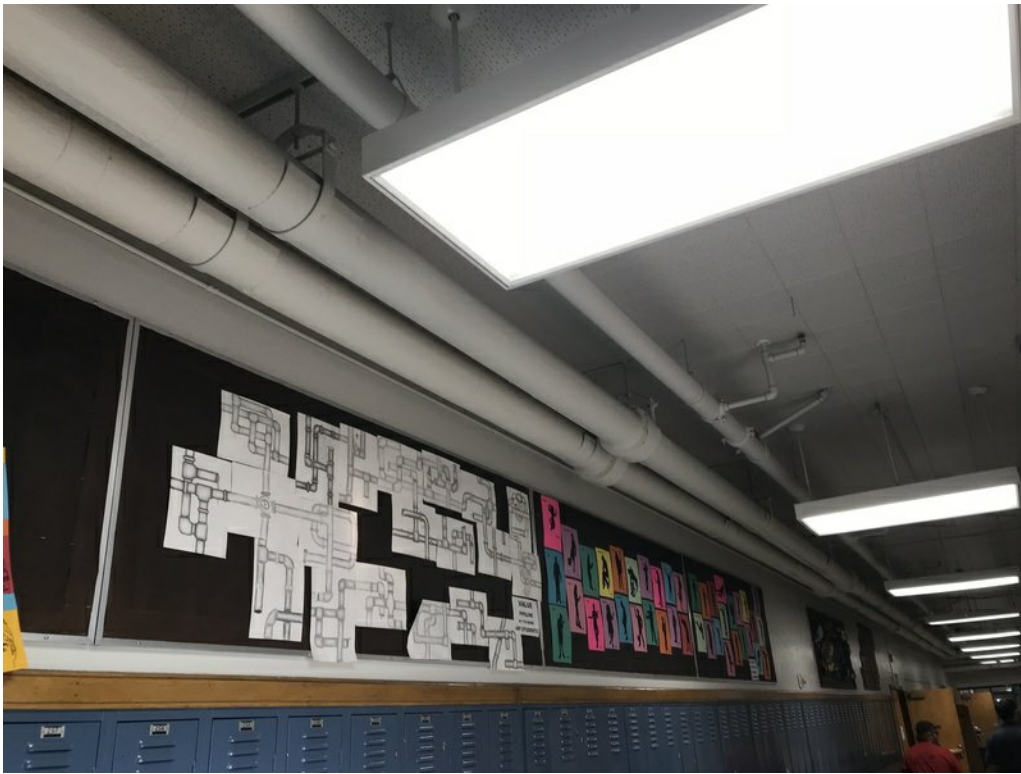
Figure 1-3. Piping in corridor; all fire suppression piping braced as shown in picture.

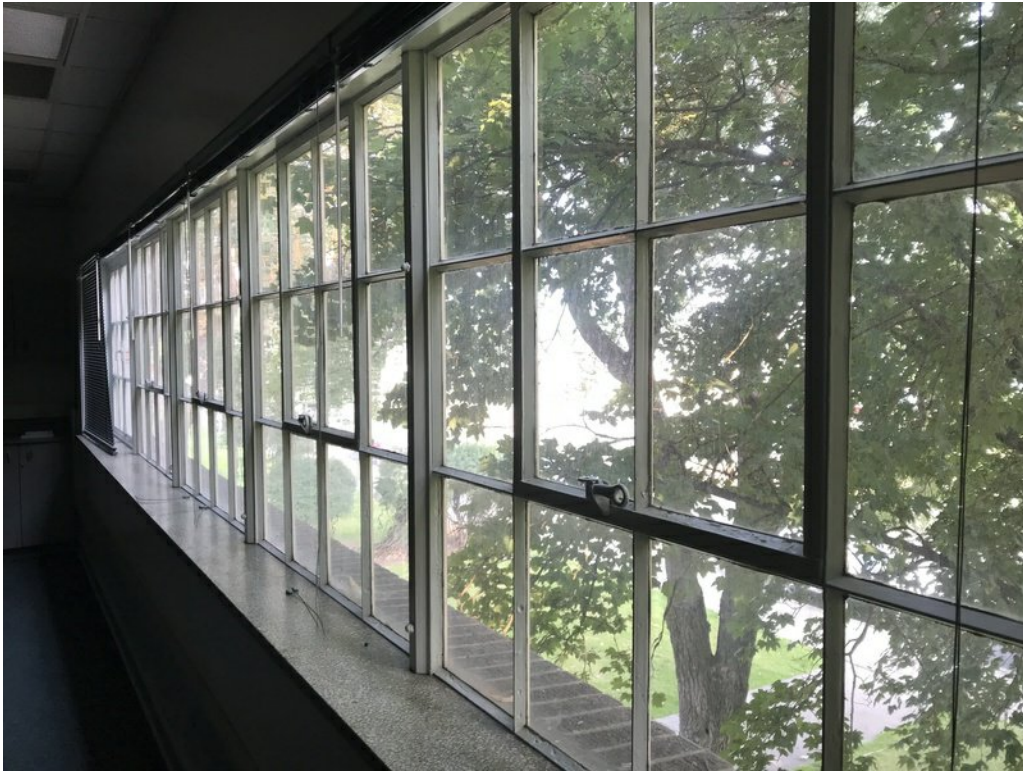
Figure 1-5. Single-pane windows; a good representation of the majority of windows in the structure.

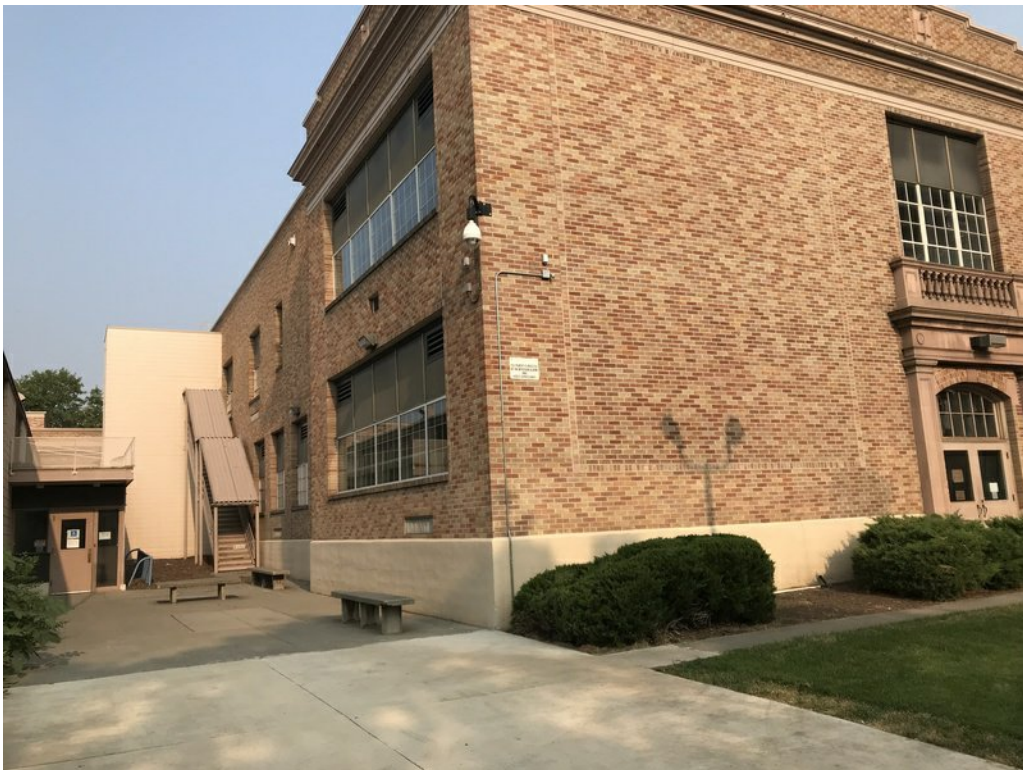
Figure 1-6. Southeast corner of north wing.

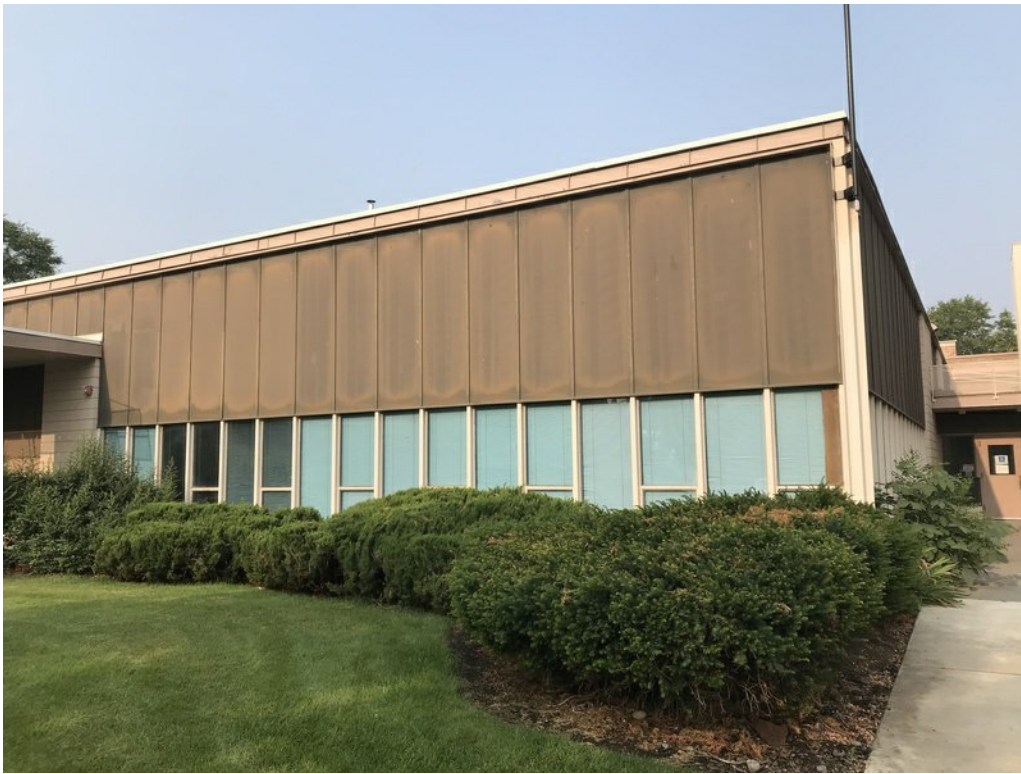
Figure 1-7. East face of center wing. Addition of an unknown date.

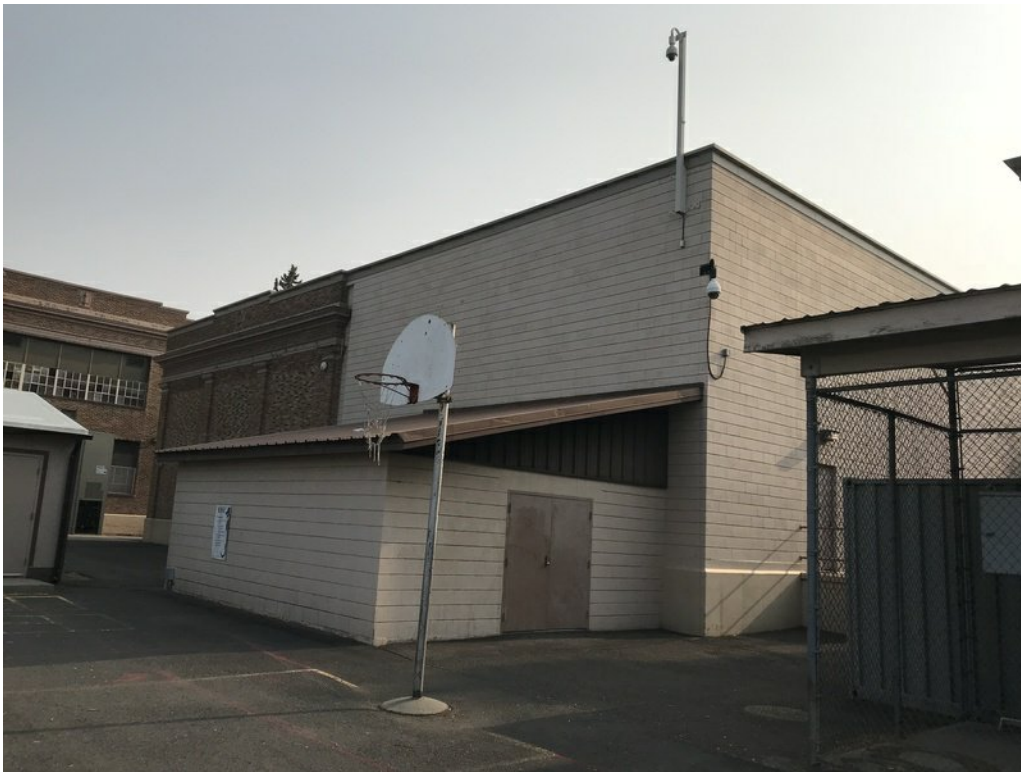
Figure 1-9. Southwest corner of central wing.
